Debris/Ice/TPS Assessment and Integrated Photographic Analysis of Shuttle Mission STS-89

**DEBRIS/ICE/TPS ASSESSMENT
AND
INTEGRATED PHOTOGRAPHIC ANALYSIS
OF
SHUTTLE MISSION STS-89**

22 January 1998

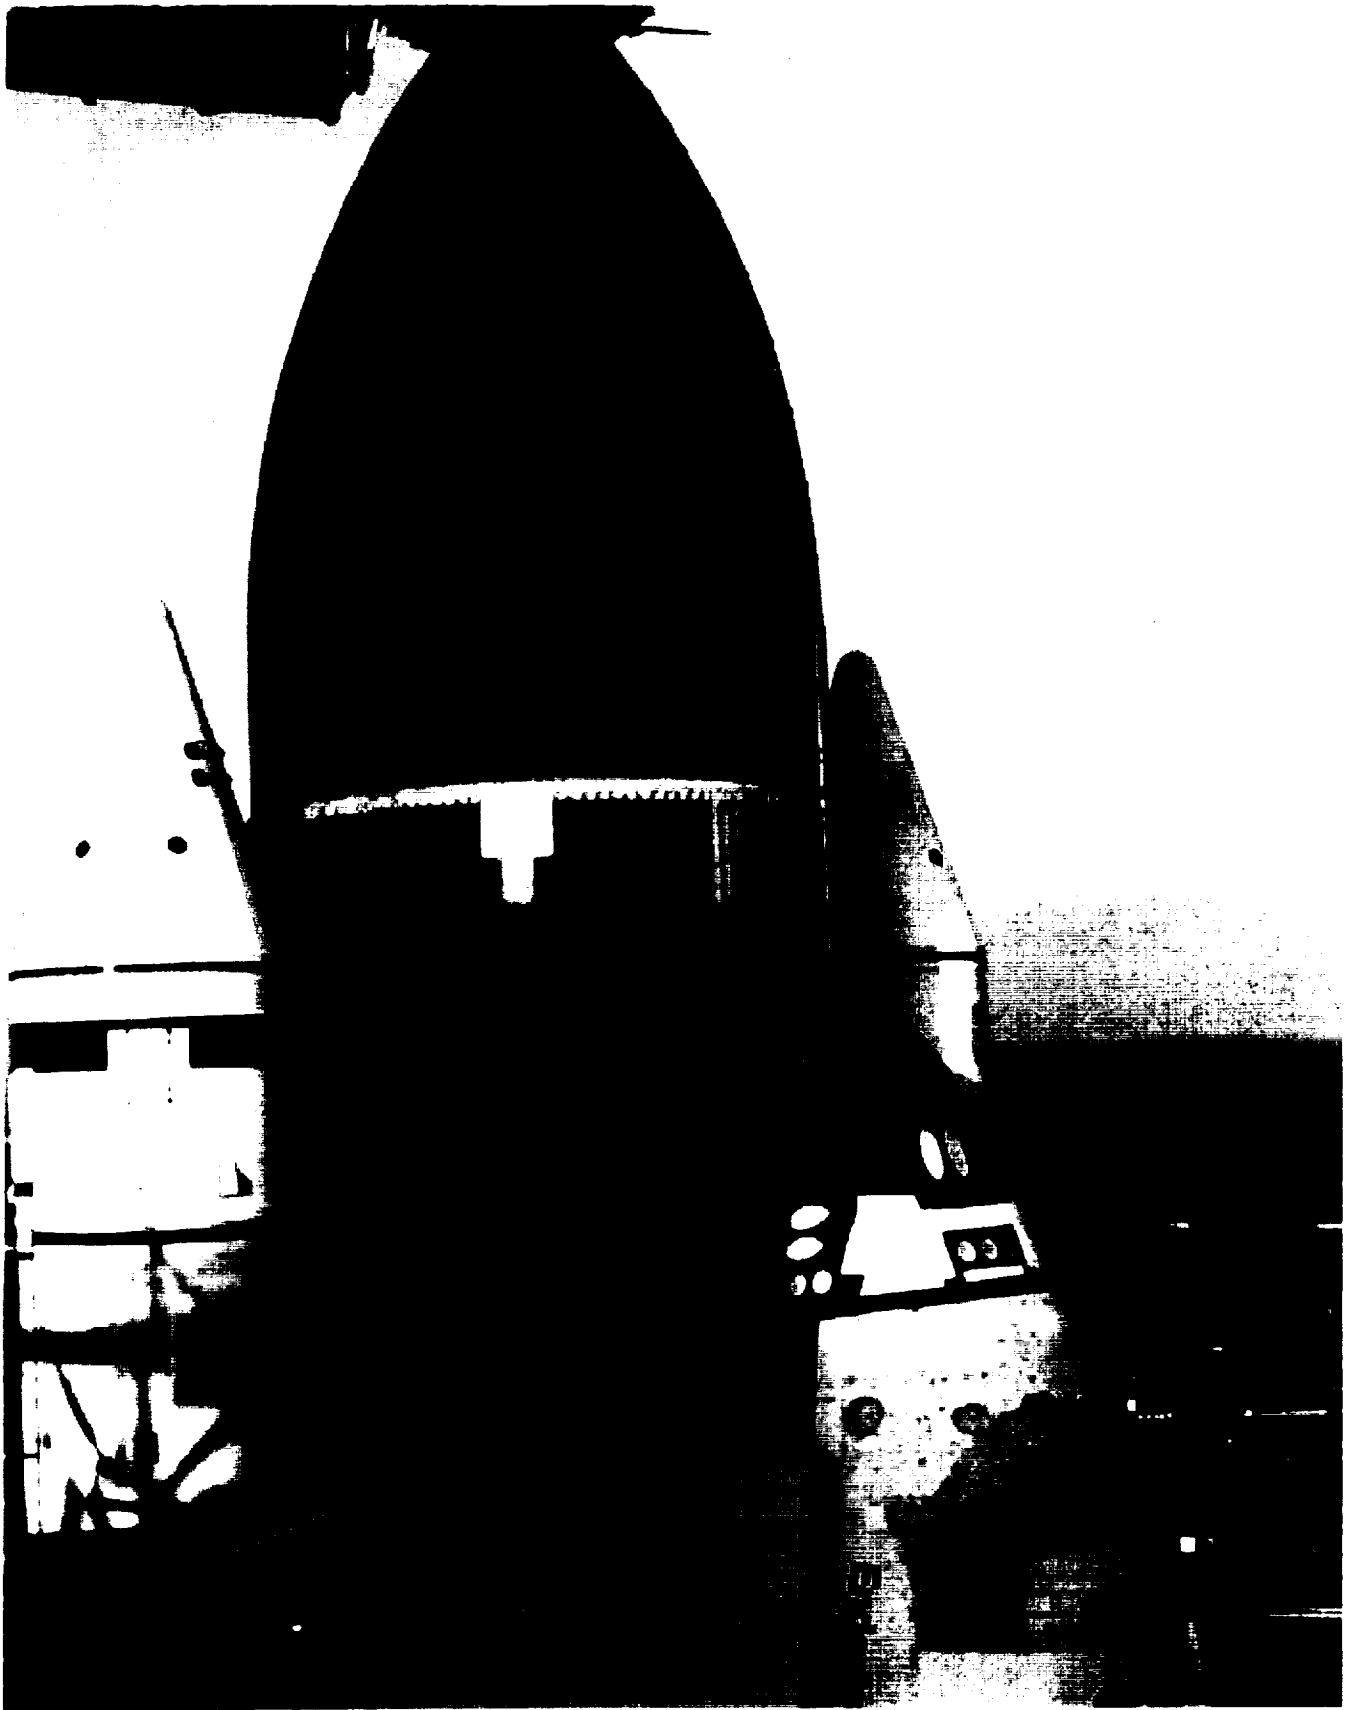
Photo 3: LO2 Tank After Cryoload

The Final Inspection Team observed very light condensate, but no ice or frost accumulations, on the LO2 tank acreage. TPS surface temperatures averaged 62 degrees F. Note configuration change to the -Y thrust panel, which had been sanded.

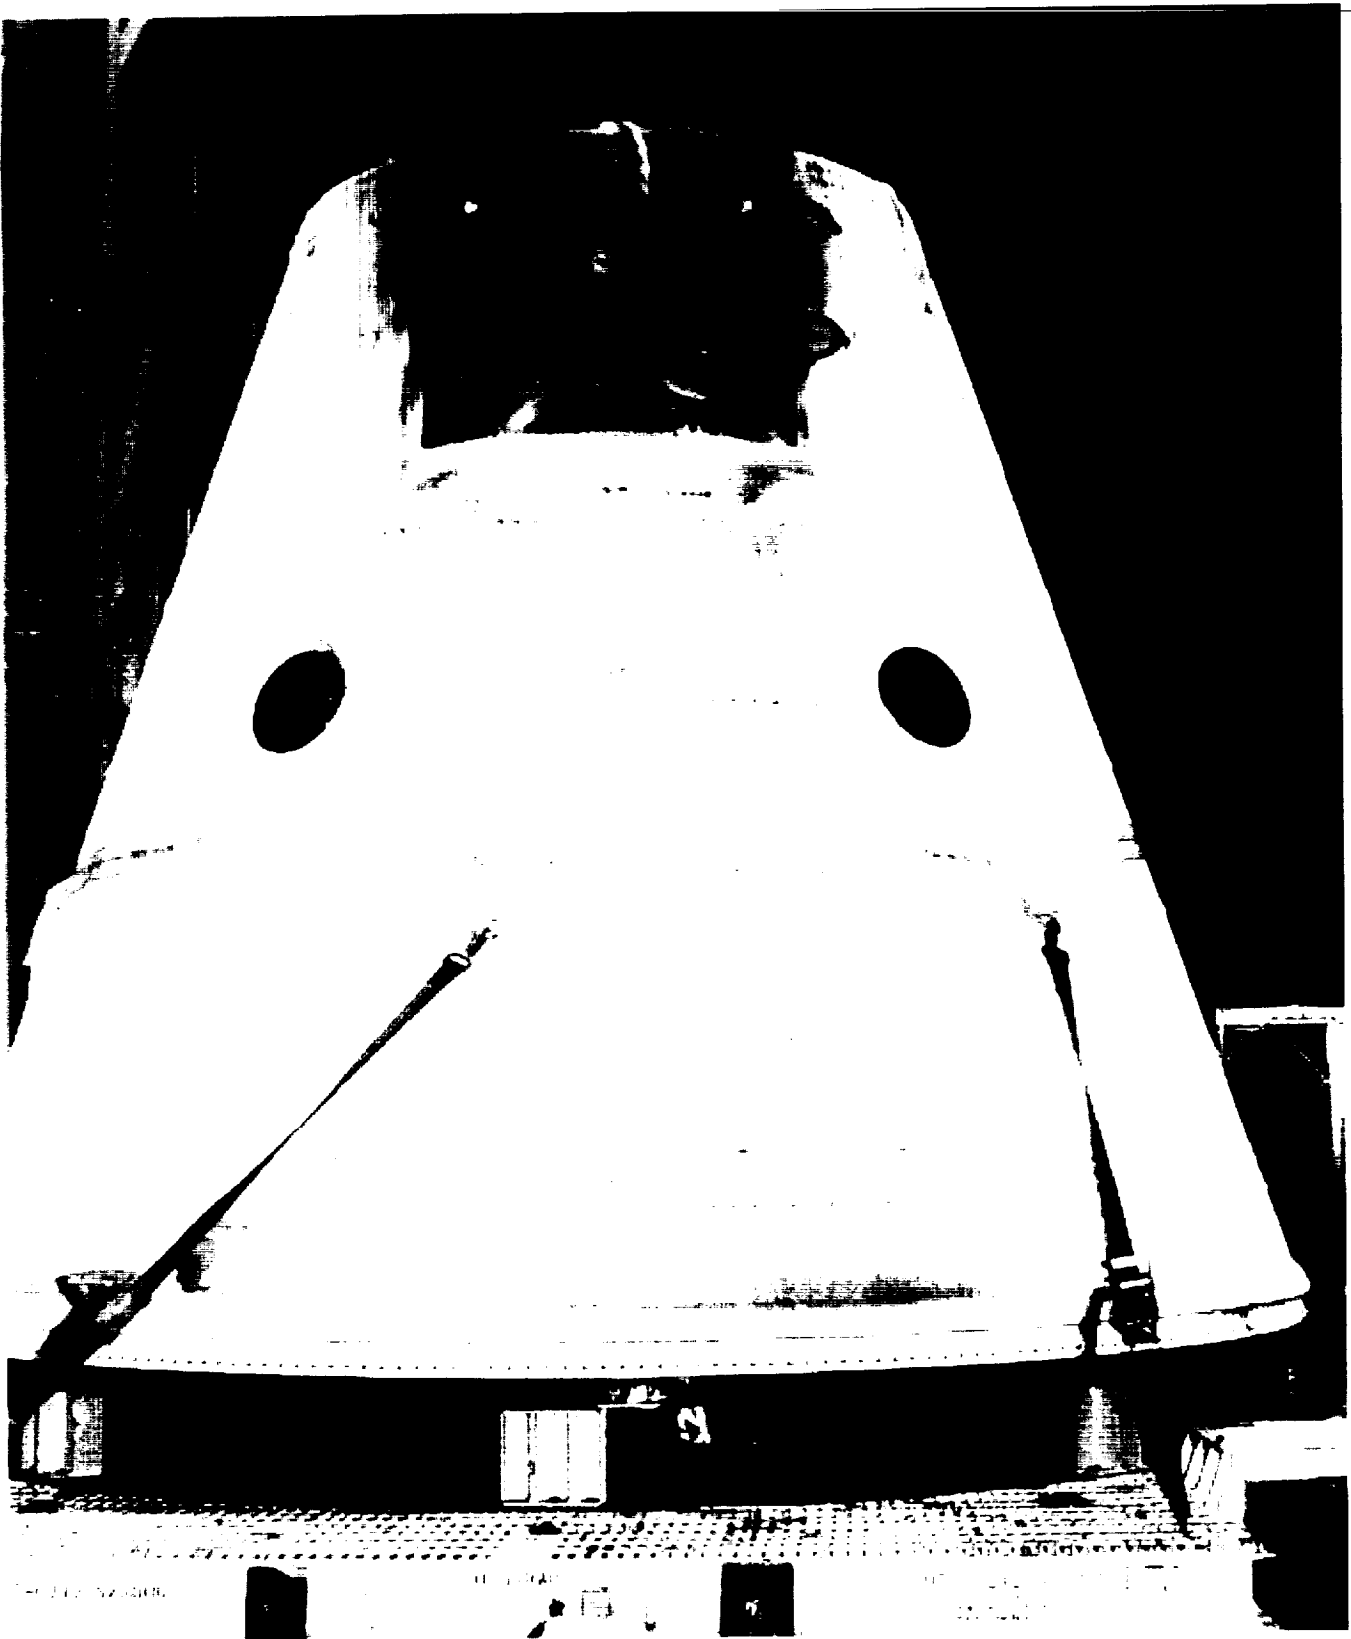
Photo 14: Frustum Post Flight Condition

Both frustums were in excellent condition. No TPS was missing and no debonds/unbonds were detected over fasteners. All eight BSM aero heat shield covers had locked in the fully opened position though the attach ring on the lower left cover of the right frustum had been bent by parachute riser entanglement. Note: a configuration change had been made to the frustums. The PR-1422 sealant/cap closeouts had been eliminated from the majority of the fastener heads prior to the application of ablator. There were no debonds, unbonds, or missing TPS associated with this change.
